FHWA- INVESTIGATION OF THE EFFECTIVENESS OF EXISTING
RD- GE DESIGN METHODOLOGY IN PROVIDING ADEQUATE
73-13 STRUCTURAL RESISTANCE TO SEISMIC DISTURBANCES.

Phase I: Literature Survey

T. Iwasaki, J. Penzien, and R. Clough

November 1972
Final Report

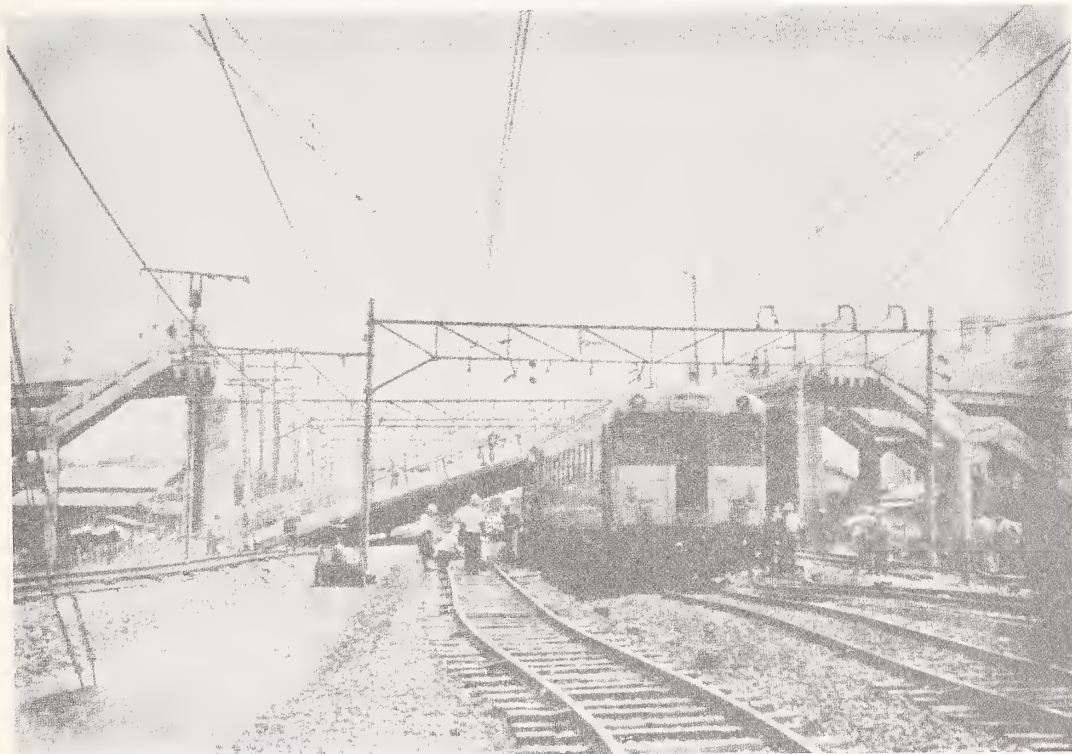
Photo.2.53 Damage to the end of the tenth girder
at the ninth pier of the Yachiyo
bridge.

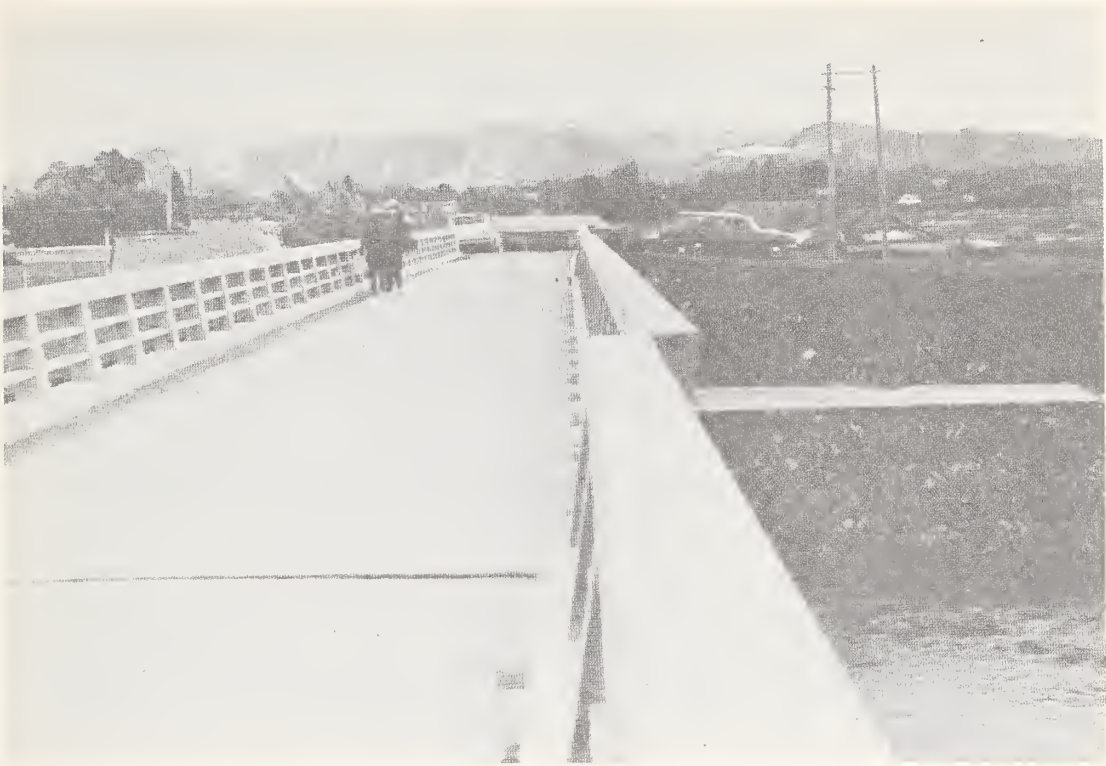
Photo.2.60 Damage to the PC girder and
the abutment of the Kamezawa bridge.

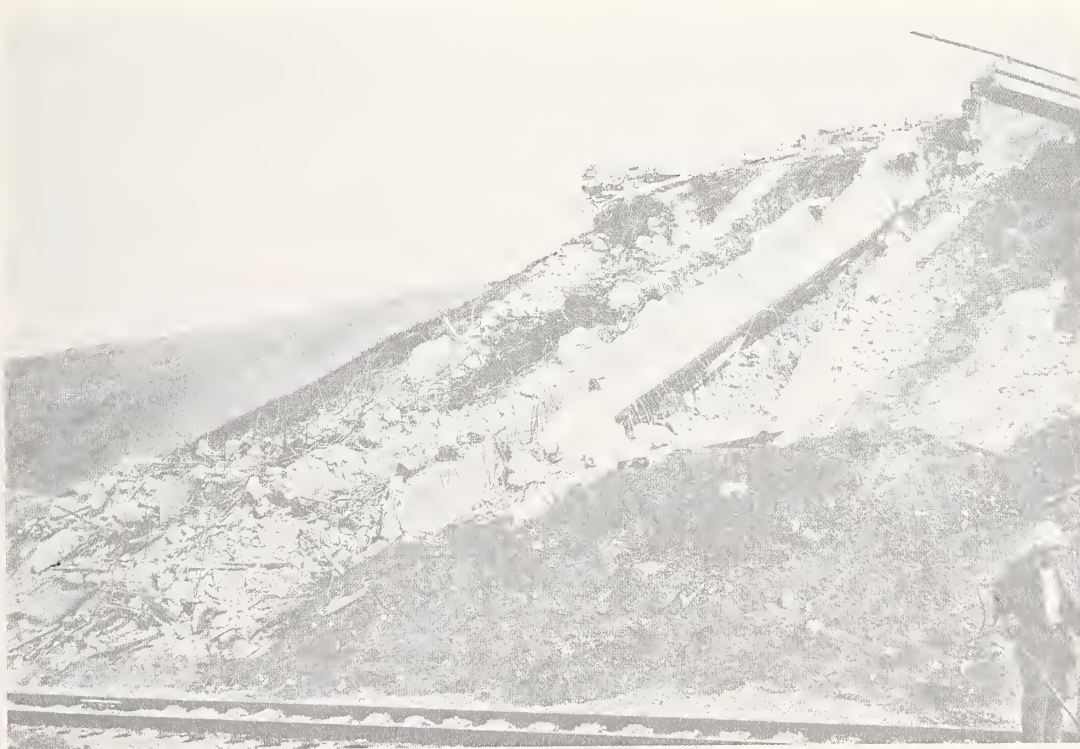
Photo. 2.69 Failure of the concrete girders
of the Komoto bridge

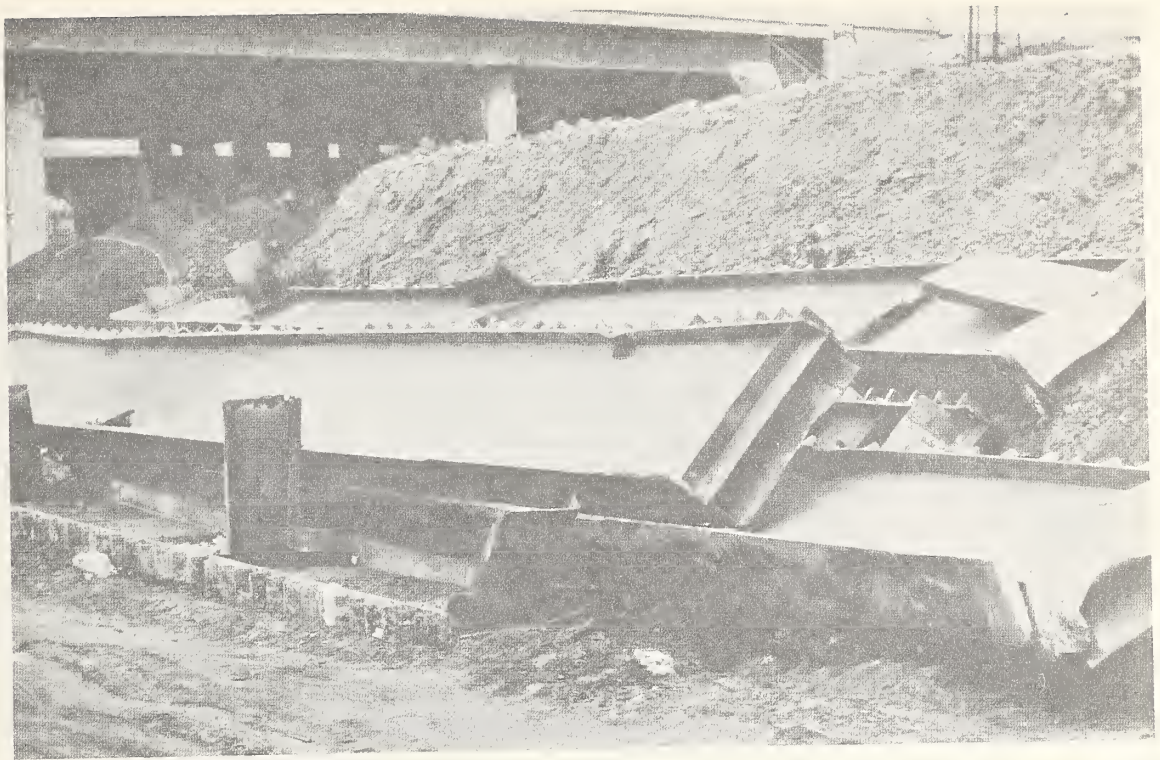
Photo. 2.72 Damaged San Fernando Road Overhead

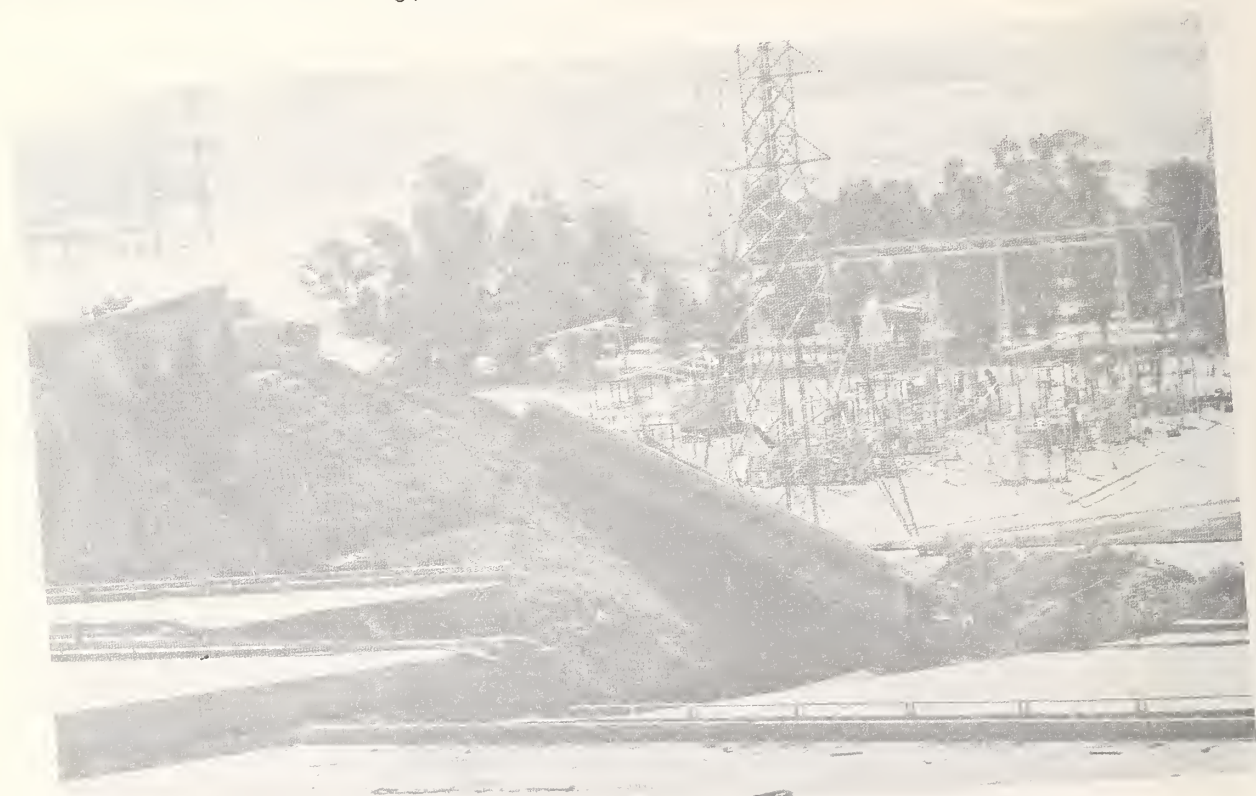
Photo. 2.83 Settlement of backfill - San Fernando Road Overhead

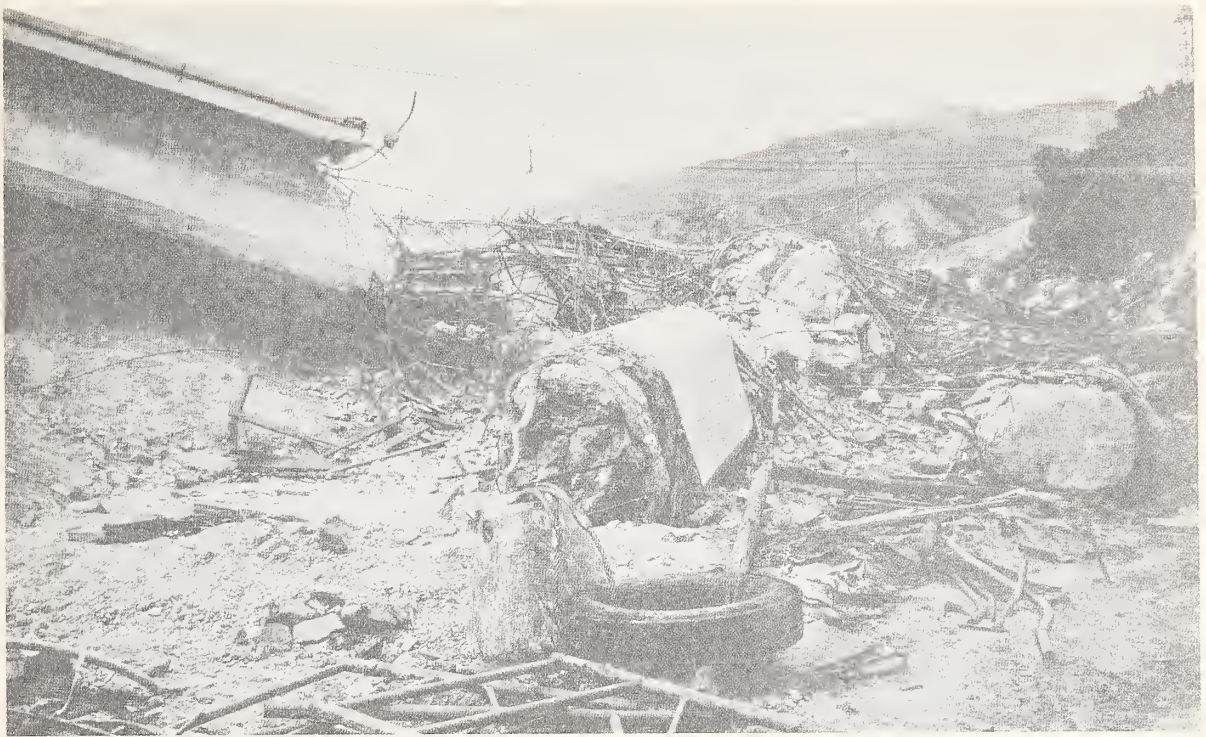
Photo. 2.84 Damaged overcrossing at Golden State Freeway and Foothill Freeway interchange

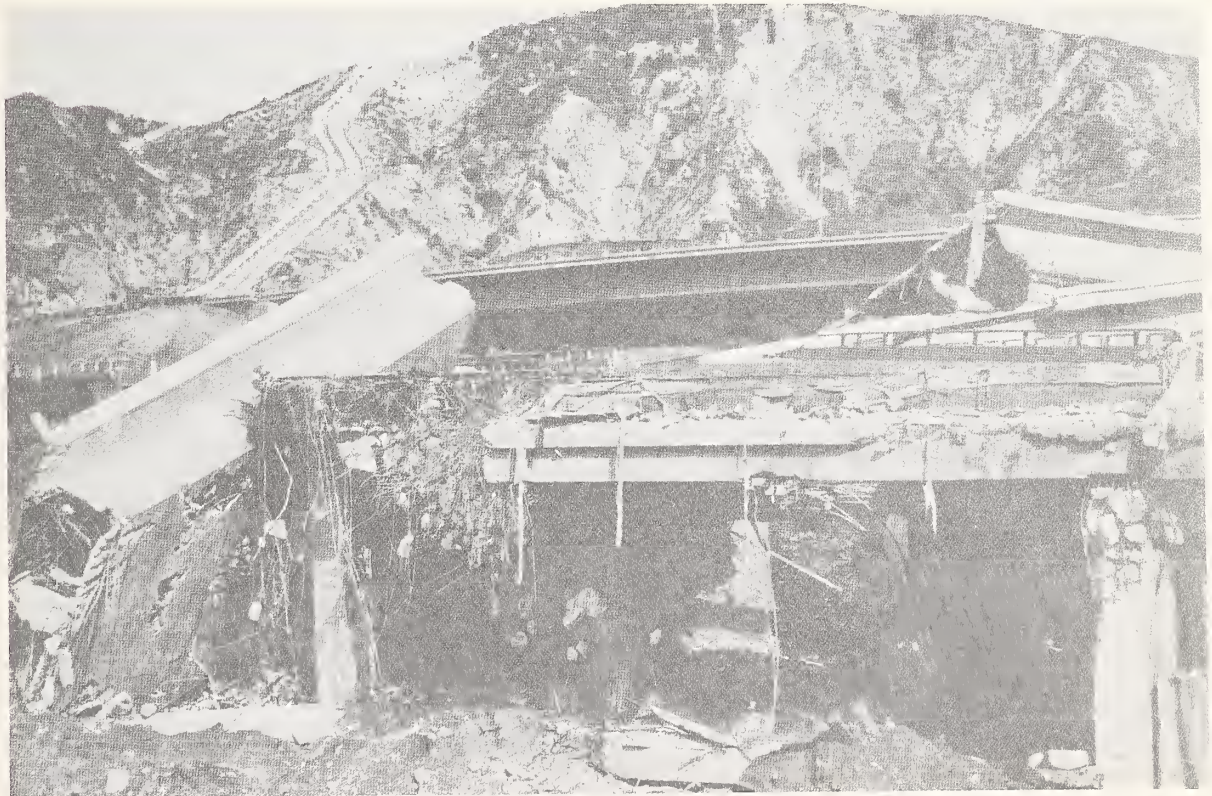
Photo. 2.85 Damaged overcrossing at Golden State Freeway
and Foothill Freeway interchange

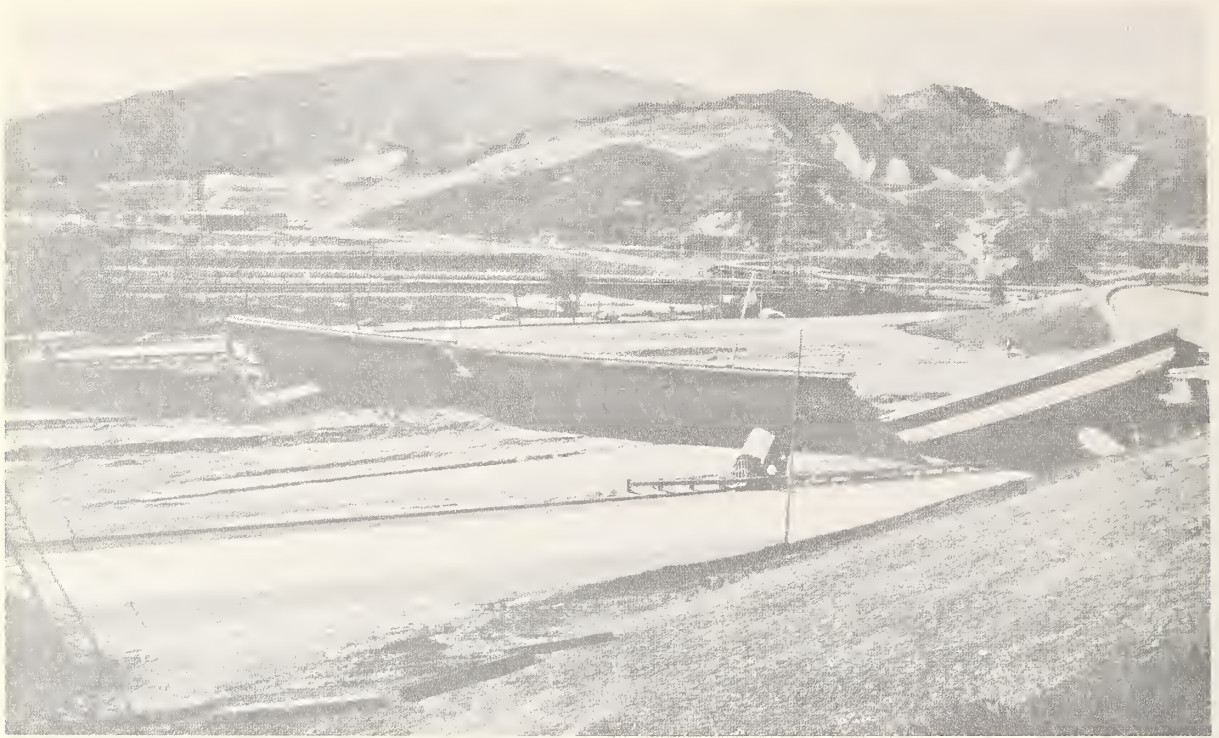
Photo. 2.86 Damaged overcrossing at Golden State Freeway
and Foothill Freeway interchange

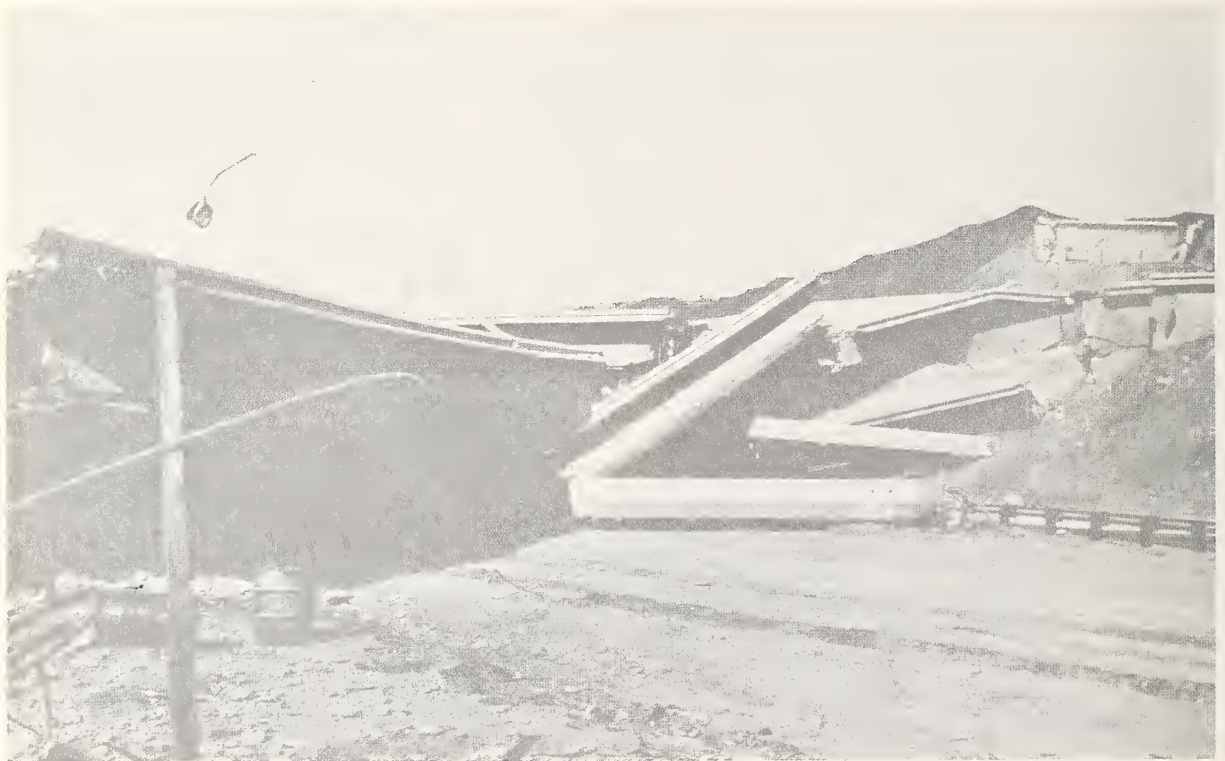
Photo. 2.87 Damaged overcrossing at Golden State Freeway
and Foothill Freeway interchange

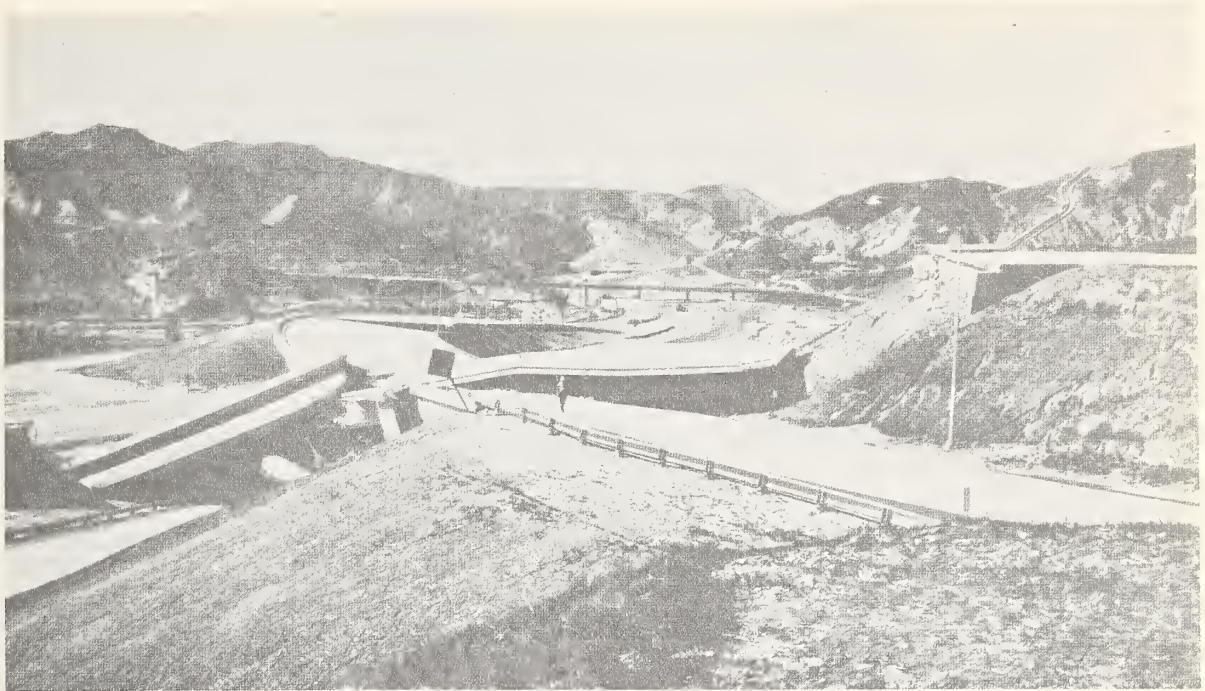
Photo. 2.88 Damaged overcrossing at Golden State Freeway
and Foothill Freeway interchange

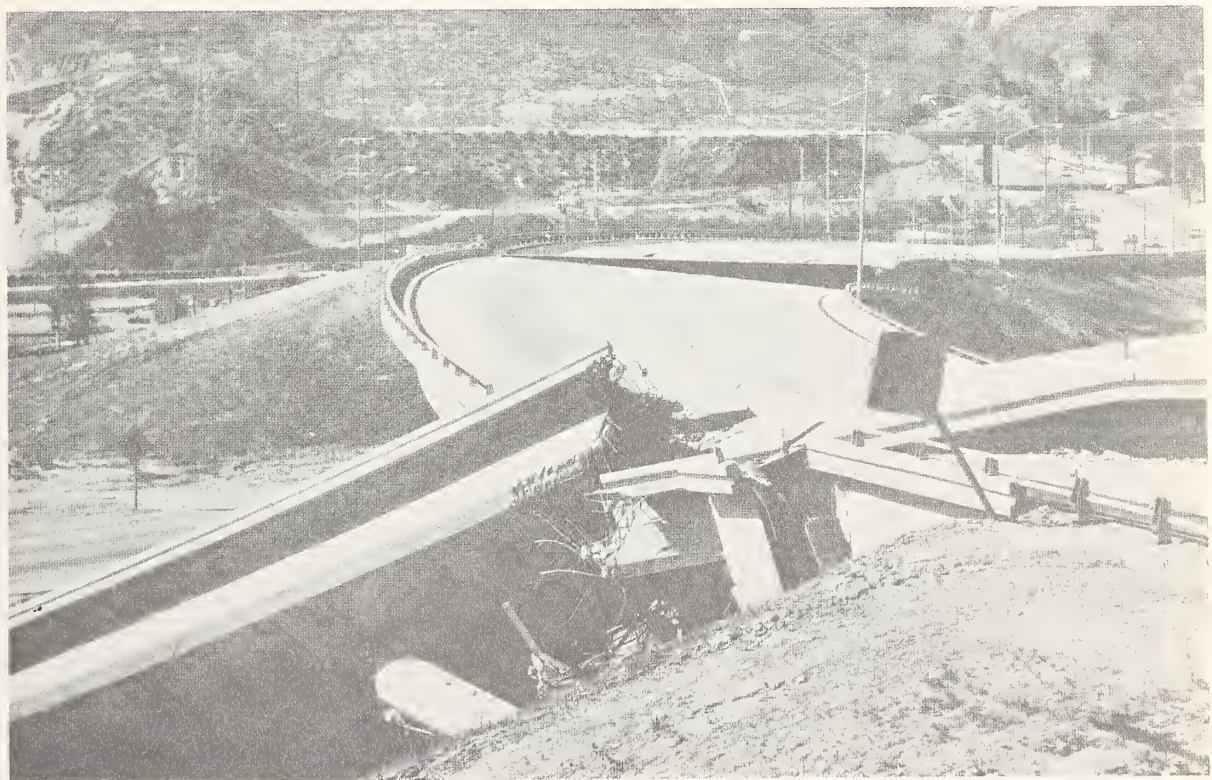
Photo. 2.89 Damaged overcrossing at Golden State Freeway
and Foothill Freeway interchange

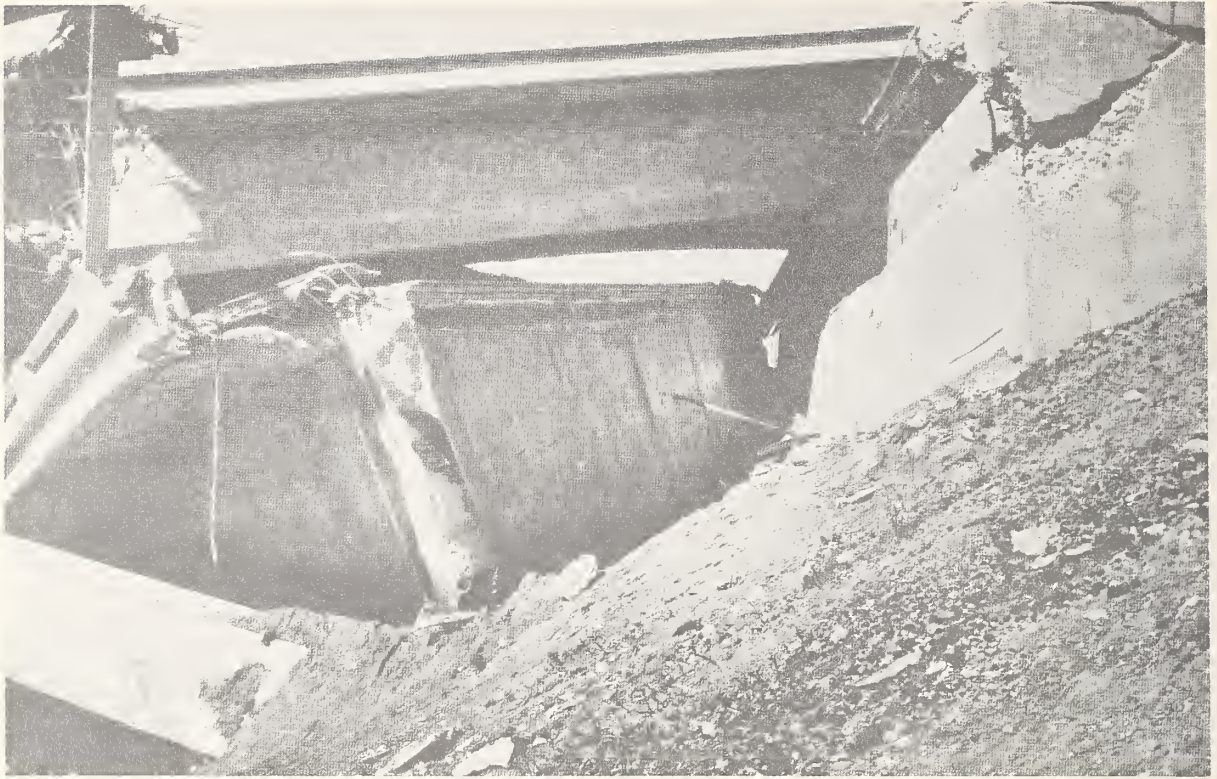
Photo. 2.90 Damaged overcrossing at Golden State Freeway
and Foothill Freeway interchange

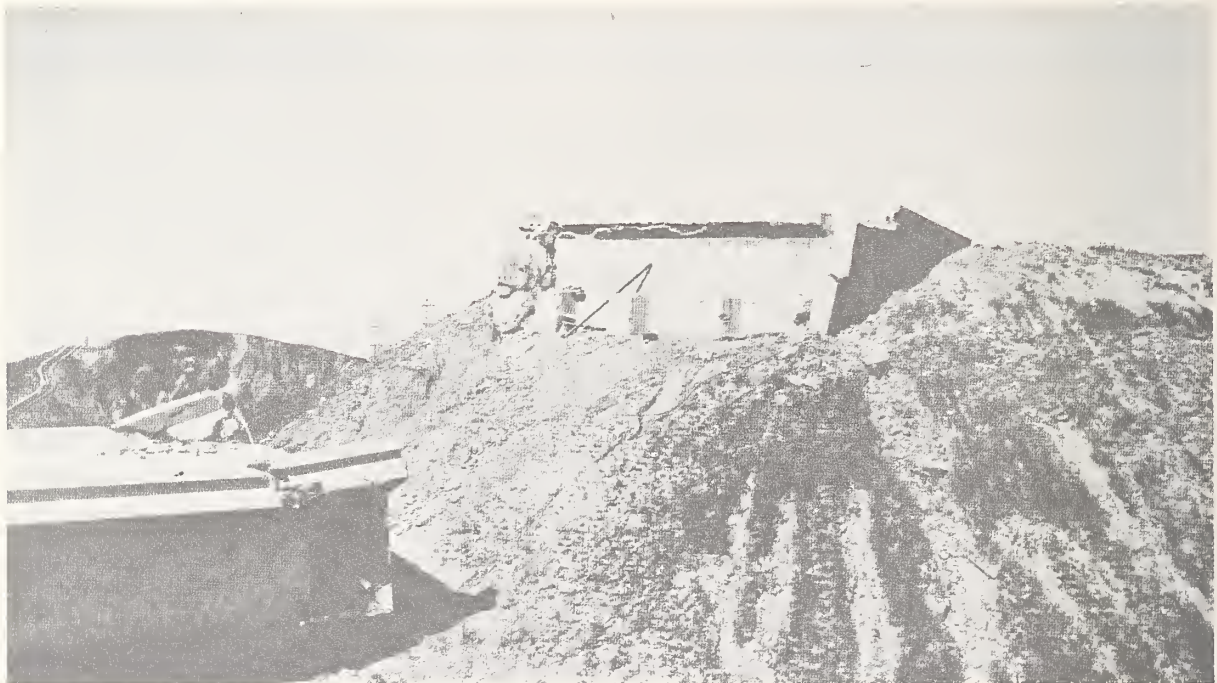
Photo. 2.91 Damaged overcrossing at Golden State Freeway
and Foothill Freeway interchange

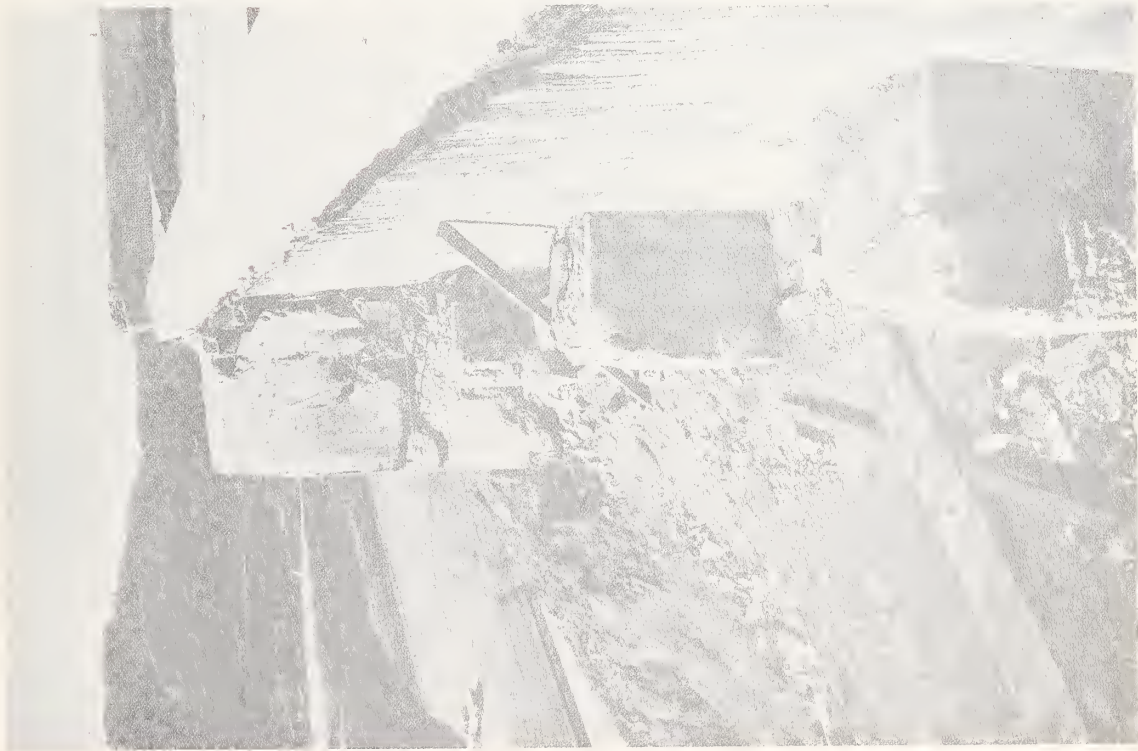
Photo. 2.92 Damaged overcrossing at Golden State Freeway
and Foothill Freeway interchange

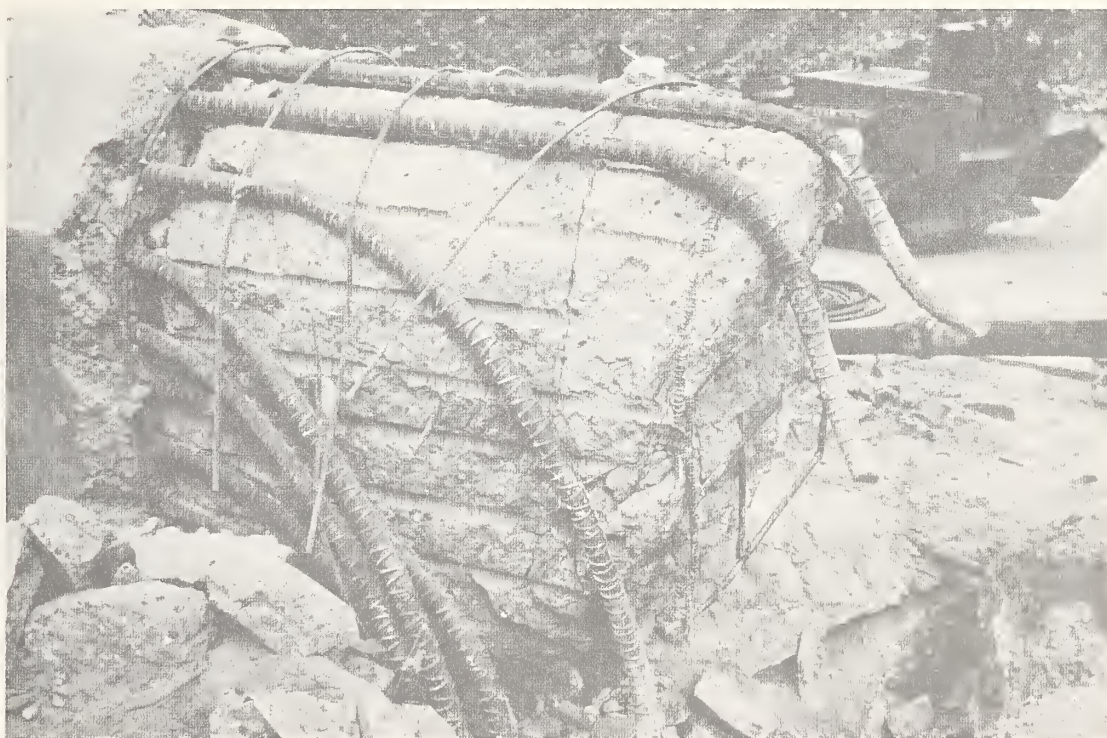
Photo. 2.97 Failure at base of column supported on a single 6 foot diameter cast-in-drilled-hole pile - Golden State Freeway and Foothill Freeway interchange

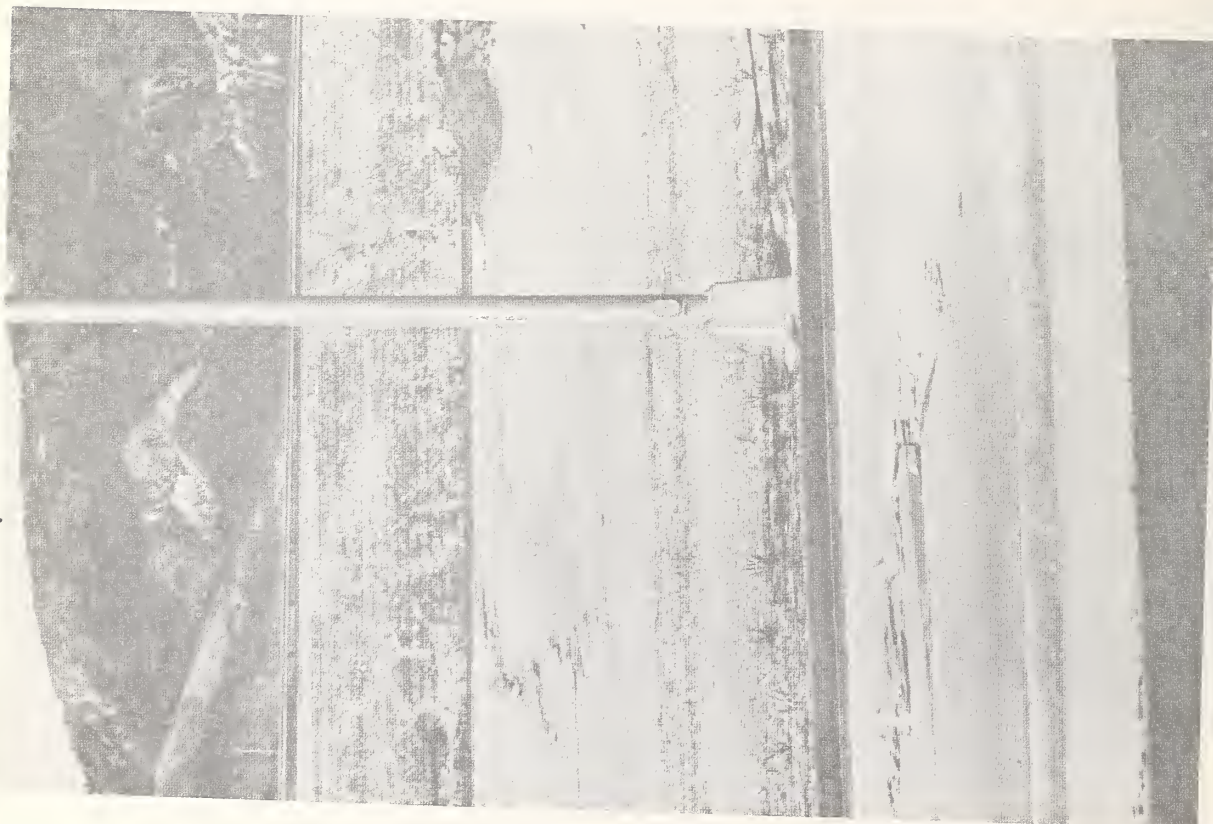
Photo. 2.98 Failure at base of column supported on spread footing - Golden State Freeway and Foothill Freeway interchange

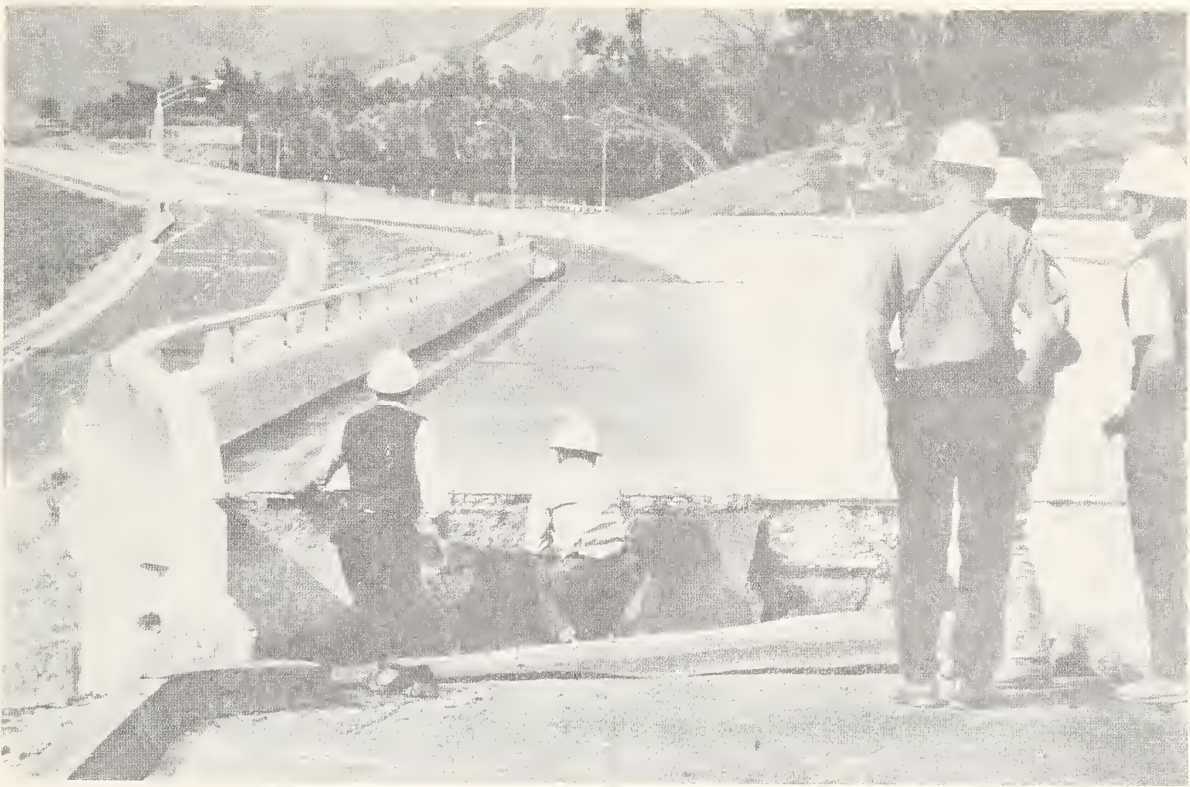
Photo. 2.120 Damaged concrete apron on abutment slope -
Roxford Street Undercrossing at Foothill
Freeway

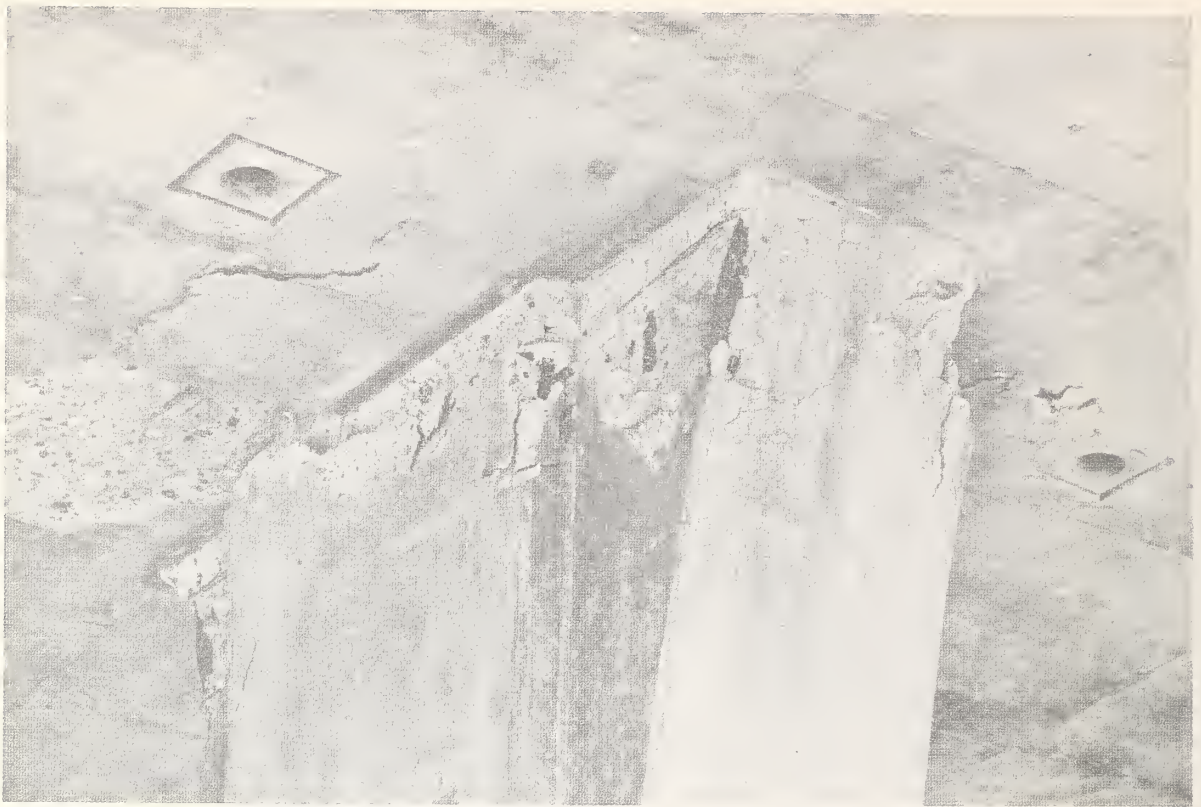
Photo. 2.138 Flexural damage at top of column - Tyler Street Pedestrian Overcrossing at Foothill Freeway

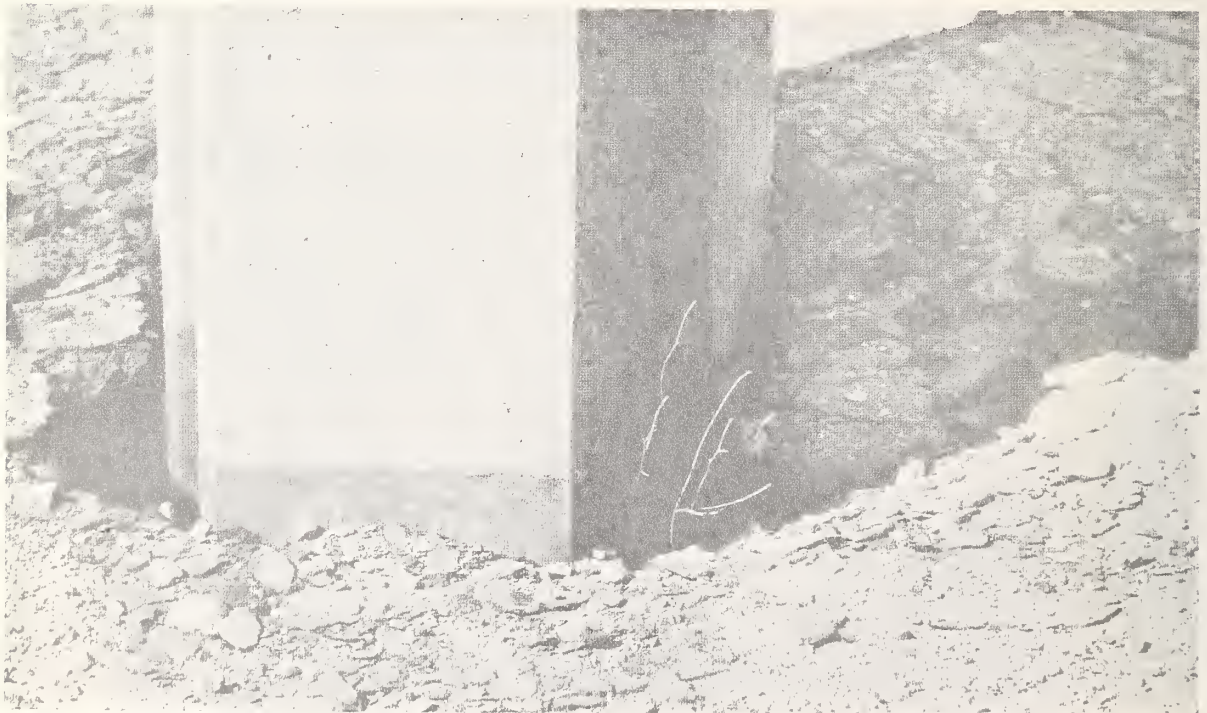
Photo. 2.139 Flexural damage at top of column - Tyler Street
Pedestrian Overcrossing at Foothill Freeway

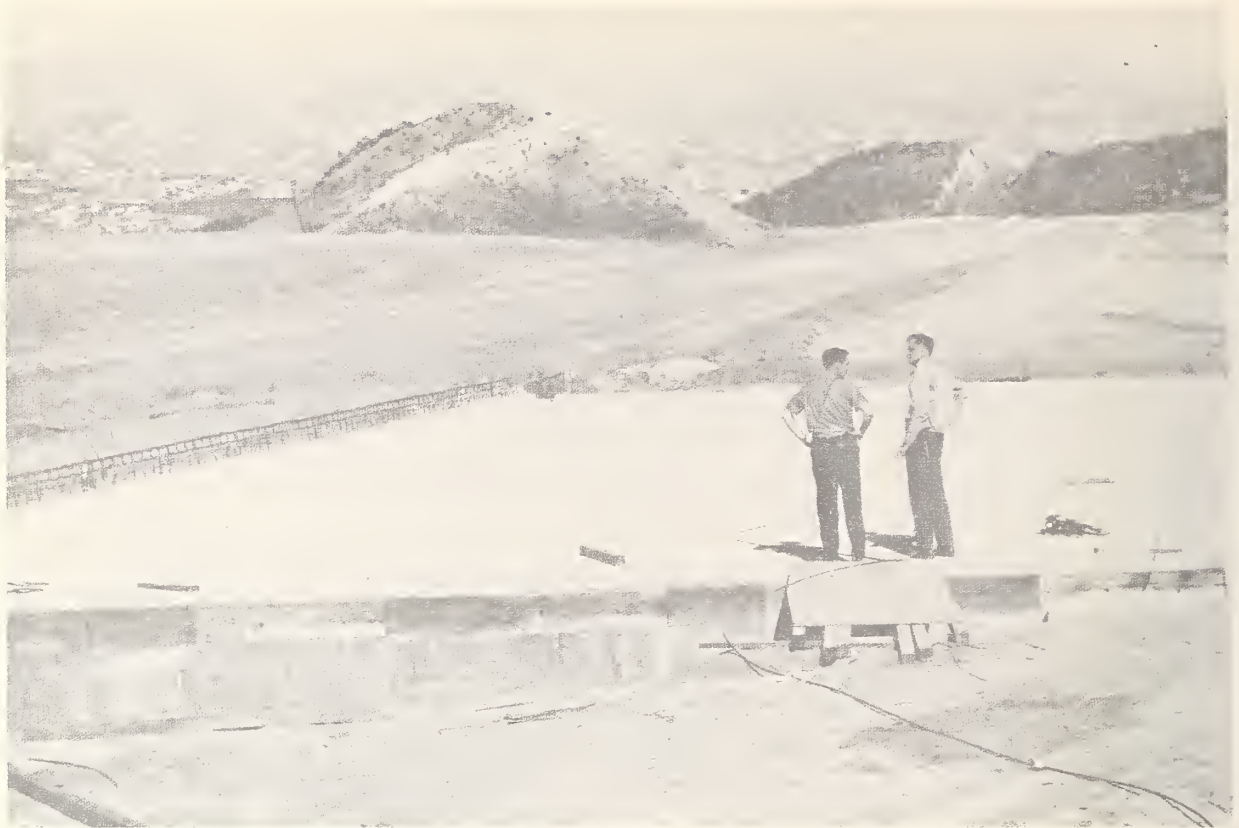
Photo. 2.142 Damaged wing wall of culvert
which passes under Foothill
Freeway
